Project: AGOR 28	Contract No.: N00014- 12-C-0305	Shipyard: Dakota Creek Industries		
Prepared by:	Date:	Program Officer:		
Paul D. Bueren	December 18, 2014	Robert (Tim) Schnoor		
Scripps Institution of		Office of Naval Research		
Oceanography (SIO)		875 Randolph St		
297 Rosecrans St.		ONR 321		
San Diego, CA 98106		Arlington, VA 22203-1995		
<b>Distribution Statement A</b> : A distribution unlimited.	pproved for public release;	Report No. A002.069

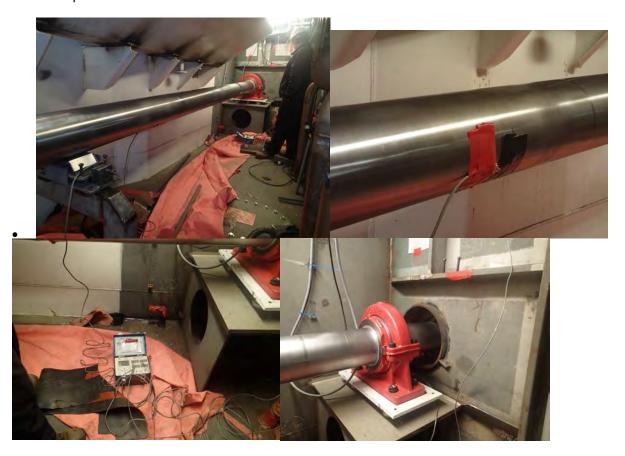
Form Approved OMB No. 0704-0188 • Intermediate Shaft Bearings - LAMALO was on site to check the shaft loading on both vessels. For Ride, the starboard shaft was checked and found to be good. The port shaft was found to have a slightly elevated side loading after the initial check. The PCU was moved about 10/1000 to reduce this. As second check was made with shaft loading found to be good. For the test 6-each strain gauges were spot welded to the shaft; three between the stern tube seal and the PCU, and three between the PCU and propulsion motor coupling. DCI will be doing no load testing on Neil Armstrong next Monday and Tuesday, as the manufacture has a recommended run in period.

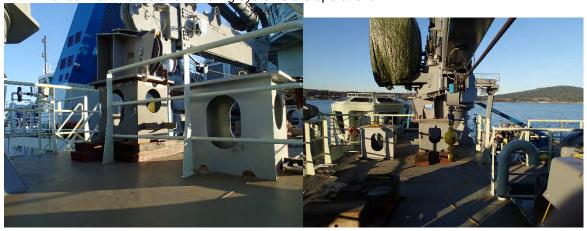
Side & CTD Handling Systems – Unresolved issues with fairlead interferences from TK70-70 main crane remain. No changes since last reported. DCI is using Sally Ride's aft fairlead foundation to test various new locations on Armstrong. Ride's foundation was not permanently fixed so this is acceptable. The foundation was moved laterally to a position just inboard of the crane's boom and raised approximately 8-inches. This will allow the wire from the aft winch to pass aft of the cranes snout. It also appears that the forward winch will also be able to utilize this change in configuration. No permanent changes should be made until both winches and handling devices are operational. For the fwd winch and CTD handling device, issues still remain in regards to possible interference with the crane's winch and crutch. These can best be verified once the winches and handling systems are operational.

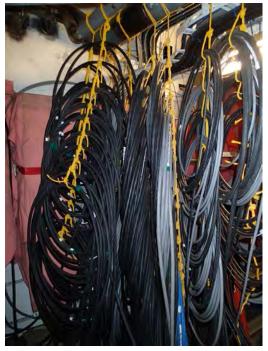
Electricians are making connection to the 480-volt bus from the two 1500-kva ship's service transformers. Cable for multiple systems has been placed in cable ways and coiled, ready for termination.
